**NYSDEC  
Division of Water**

**A Primer on Aquatic Plant Management  
in New York State**

**April 2005**

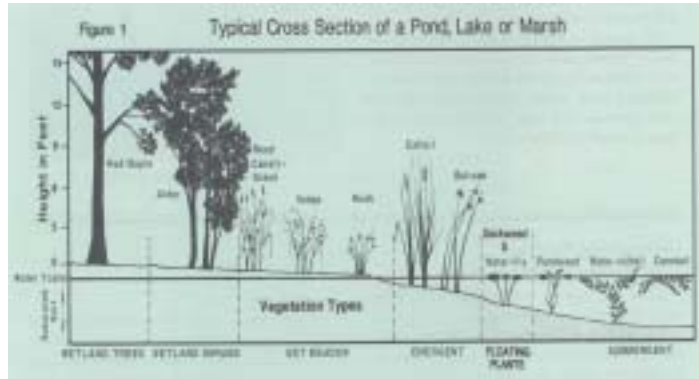
Just beyond the emergent plants, **floating-leaf plants**, such as water lilies, watershield, and more delicate unrooted plants such as duckweed and watermeal, are found. Like emergent plants, they are rooted under the water (sometimes with thick, hearty rootstocks (**rhizomes**)), but the floating leaves usually constitute the bulk of the plant mass. These floating leaves shield out the light transmitted below the plant, reducing the amount of underwater plant growth (within the stems of the floating leaf plants as well as other low-lying plants). These plants grow in water from a few inches deep (the duckweed and watermeal, which look like surface algae from a distance) to as much as 6-8 feet deep. Although floating-leaf plants tend to grow in the most heavily used parts of lakes and ponds, they are usually not associated with nuisance conditions.

Beyond this area occur **submersed plants** such as pondweeds and milfoil. These are perhaps the most diverse of the aquatic plants, ranging from tiny grass-like plants that barely peek above the sediment layer, well-hidden in up to 20 feet of water, to very tall, very conspicuous leafy plants that look a little like redwoods when viewed from the lake bottom. Some of these plants sprout a floating leaf or rosetta of leaves, and even a spike of flowers above the surface, although the bulk of the plant still resides under the water surface. Others grow to the lake surface and then spread laterally, forming a dense canopy that ultimately prevents other plants from growing under their shade. These observations reinforce the notion that the definitions of **submersed** and **floating-leaf** are somewhat arbitrary, for several plants could easily be considered as members of both groups, and plants in both groups still take up residence in the littoral zone. Several submergent plant species are regularly associated with nuisance conditions, owing to their status as exotic plants.

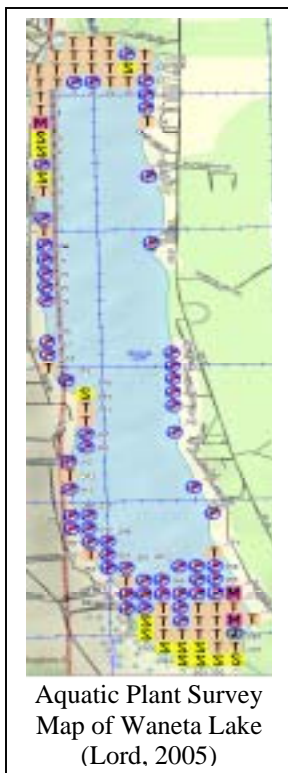
The point-intercept measurements can generate coverage maps that provide a readily understandable snapshot of plant conditions in a lake (see Figure on the left), and can, if used in methods described below, can be used as a surrogate for detailed biomass survey maps.

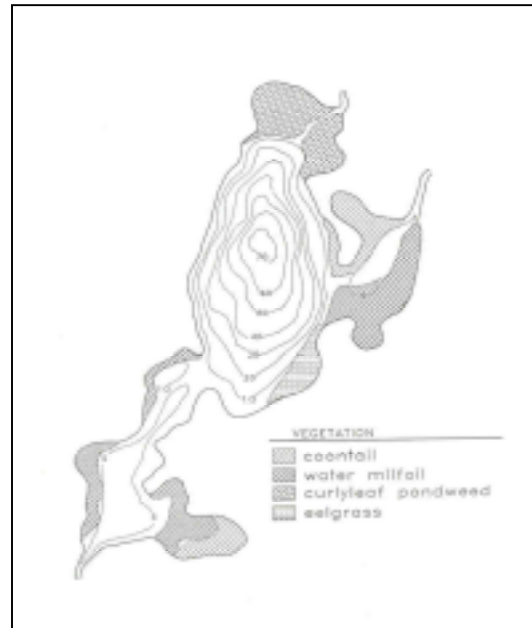
In lieu of an extensive macrophyte survey, individuals and lake associations can map the extent of vegetation coverage over the course of the year, usually during late spring to early summer and again in the fall. This can be done through aerial photography, or from on-site inspection by lake residents (preferably those who can view the lake from their rooftops!). The most common maps indicate the major plant species in each part of the lake, with little differentiation between thick beds and scattered plants. These can be seen in the figure on the right.

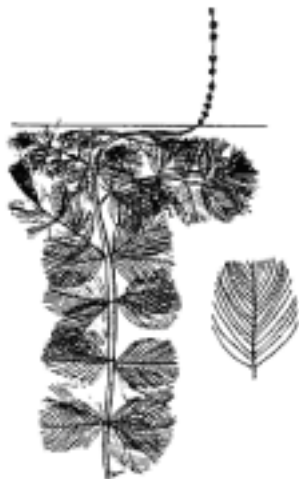
1. Eurasian watermilfoil (*Myriophyllum spicatum*) was introduced into New

York State in the 1940s, probably in the Finger Lakes region, and has since spread to every region of the state except for Long Island. It is characterized by dense canopies that spread laterally across the surface of the lake, and propagates primarily by fragmentation in pieces as small as one inch. Like most invasive exotic plants, it grows opportunistically in a wide variety of depths, water quality conditions, and sediment types, although it is mostly commonly found in sandy to mucky soils in a depth range of 3 to 12 feet. It is the most invasive submergent aquatic plant throughout New York State.

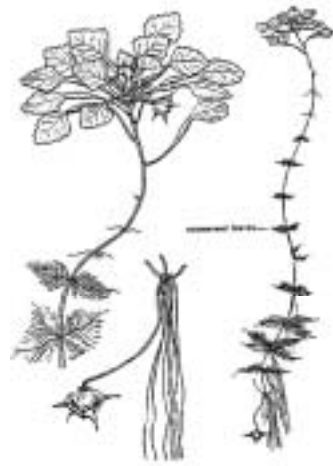
2. (Eurasian) water chestnut (*Trapa natans*) was introduced in North American and New York State in Collins Lake in Scotia in 1882, although it was found a few years earlier in an herbarium in Massachusetts. From this “epicenter”, it has largely migrated along the Lake Champlain, Mohawk River and Hudson River systems (and problems associated with water chestnut are mostly restricted to these areas), although it has been increasingly found in small lakes and ponds. It is conspicuous for a surface rosetta of leaves and a woody, spiked nutlet that serves as a seed for future generations of the plant (and is viable in bottom sediments for several decades). Water chestnut grows primarily in sluggish shallow water in mucky sediments.

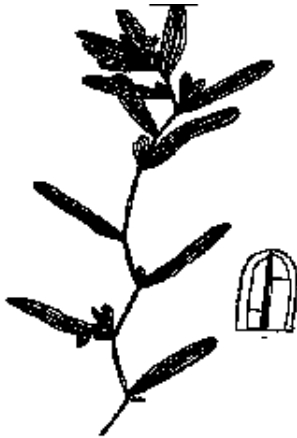
3. Curly-leafed pondweed (*Potamogeton crispus*) was probably introduced in the mid-1800s in the northeastern United States, and is found sporadically throughout the state. It is characterized by a lasagna-like curled leaf and a very early growing season. In New York lakes, the plants usually start growing under the ice and die back by late June. It spreads by seeds and sprigs. It grows in a variety of settings, but generally grows best in relatively shallow water. Curly-leafed pondweed control strategies are most often employed in the eastern and southern portions of the state.

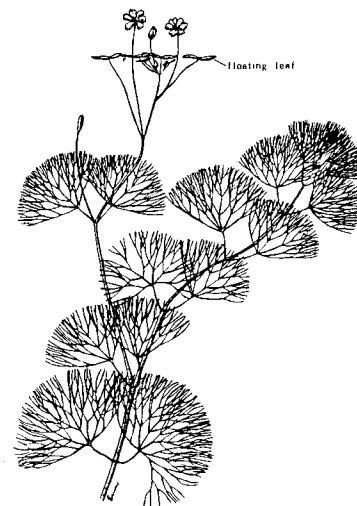
4. Fanwort (*Cabomba caroliniana*) is native to the southern states but not native to New York State or the northeastern states. It has historically been limited to Long Island (although the first sightings in New York State may have occurred in Orange County in the early 1930s), where it grows primarily in shallow water, as in most other New England states. However, in recent years it has been found in deepwaters of the isolated lakes in the southeastern Adirondacks and on both sides of the Lower Hudson River basin. It has thread-like leaves that fan out on opposite sides of the stem; while it has white or pink flowers, these rarely appear in fanwort in New York state lakes. It spreads by seeds, not by fragmentation or other asexual means. Fanwort control is mostly limited to Long Island.

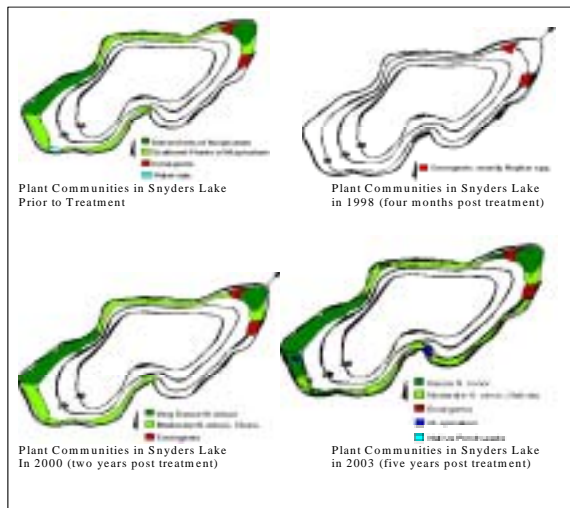
Results (cont): After 2001, milfoil recolonized large patches of the littoral zone, although it was still much less dominant than prior to treatment, due to the well-established brittle naiad beds. The milfoil spread to some areas not previously occupied by any macrophytes. The coverage and density of the milfoil/brittle naiad beds were significant enough to trigger a spot treatment with endothal in the summer of 2004 in the areas of the lake with the highest macrophytes coverage (and, perhaps not coincidentally, the highest sedimentation rate).

Most antidotal information from lake residents and visitors indicate a general satisfaction with the results of the initial treatment, with few reported complaints from anglers about the lack of a fishing edge or loss of any year-classes. Water quality conditions were relatively stable throughout the treatment and subsequent response period, and reports of blue-green algal blooms or other water quality complaints were less common than in most previous five-year periods, despite the potential available of nutrients not taken up by the rooted plants. However, this may have been more a function of more favorable weather conditions.
